A Historic Building Gets an Energy Upgrade

Satisfying the commissions while bringing an 1840s building up to 21st-century energy-efficiency standards presented a challenge

by Andrew Borgese

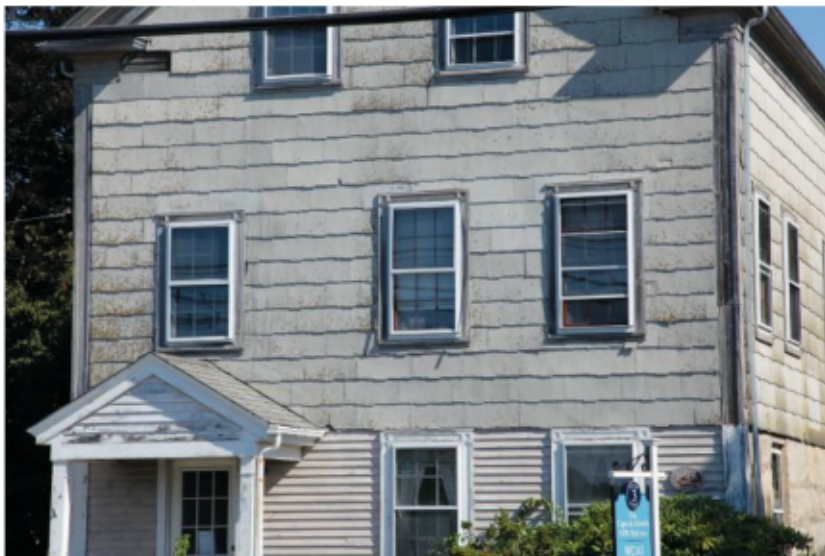
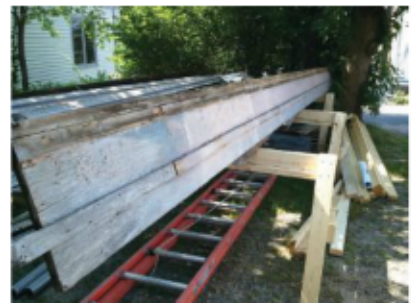
When WGBH took over the building in 2009, it was clad with asbestos shingles (see Figure 1) and the asphalt roof was failing. The walls and roof had little or no insulation, most of the exterior trim needed replacing, the two brick chimneys were crumbling, and the original double-hung windows were in poor condition. In short, the building had serious structural and energy-efficiency problems, as well as a lack of wheelchair accessibility. But its location within a historic district meant that any work done to the exterior of the

Figure 1. Before the renovation, the building was essentially sound, but the years had not been kind to it. Asbestos shingles covered the walls (left), and much of the trim had deteriorated beyond saving. As the exterior layers were peeled back, any of the original cypress trim that still had life was set aside to be reinstalled later (above).

The Standards for Rehabilitation require that materials be repaired and reused wherever possible, so as the outer layers of the building were peeled back, we set aside any such material. Once the original board sheathing was exposed, we were able to fill the empty stud cavities and rafter bays with dense-packed cellulose insulation from the outside. Next we wrapped the walls and roof with a layer of 2-inch foil-faced polyisocyanurate foam insulation, taping the seams to complete the air and moisture barrier and provide a thermal boundary (Figure 2).

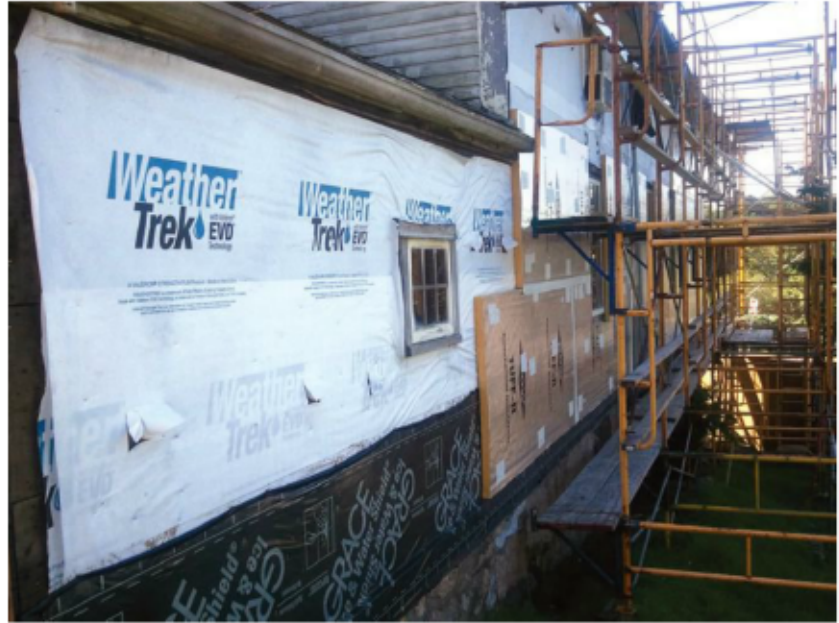
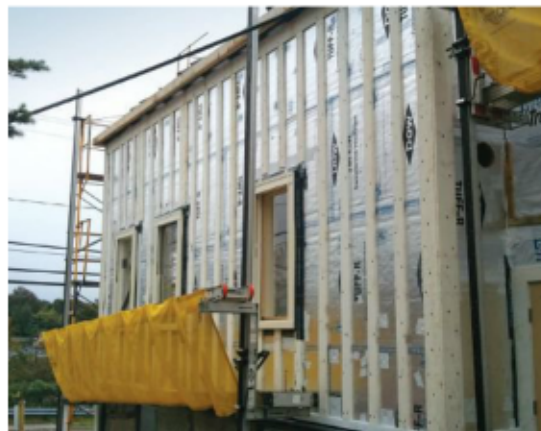
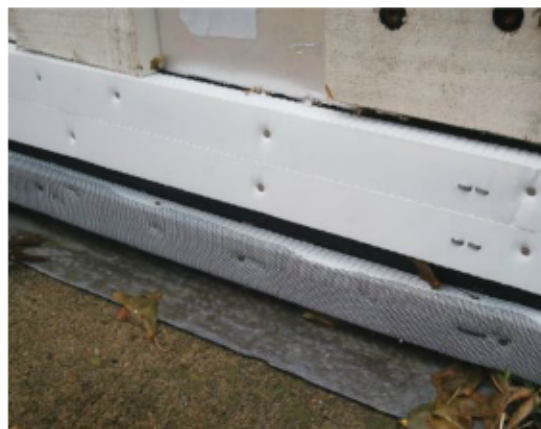
Figure 2. Before the nailing strips went on, cellulose insulation was blown into the walls; housewrap was attached to the original sheathing (above) to keep the cellulose from leaking out. Then the walls were wrapped with foil-faced foam and the seams taped. Vertical strapping was screwed through the foam and into the framing to attach the siding and trim (left). Extra stock was later added around window and door openings for nailers. Vent strips were installed at the top and bottom of each wall for drainage and to allow air to flow freely behind the clapboards (bottom).

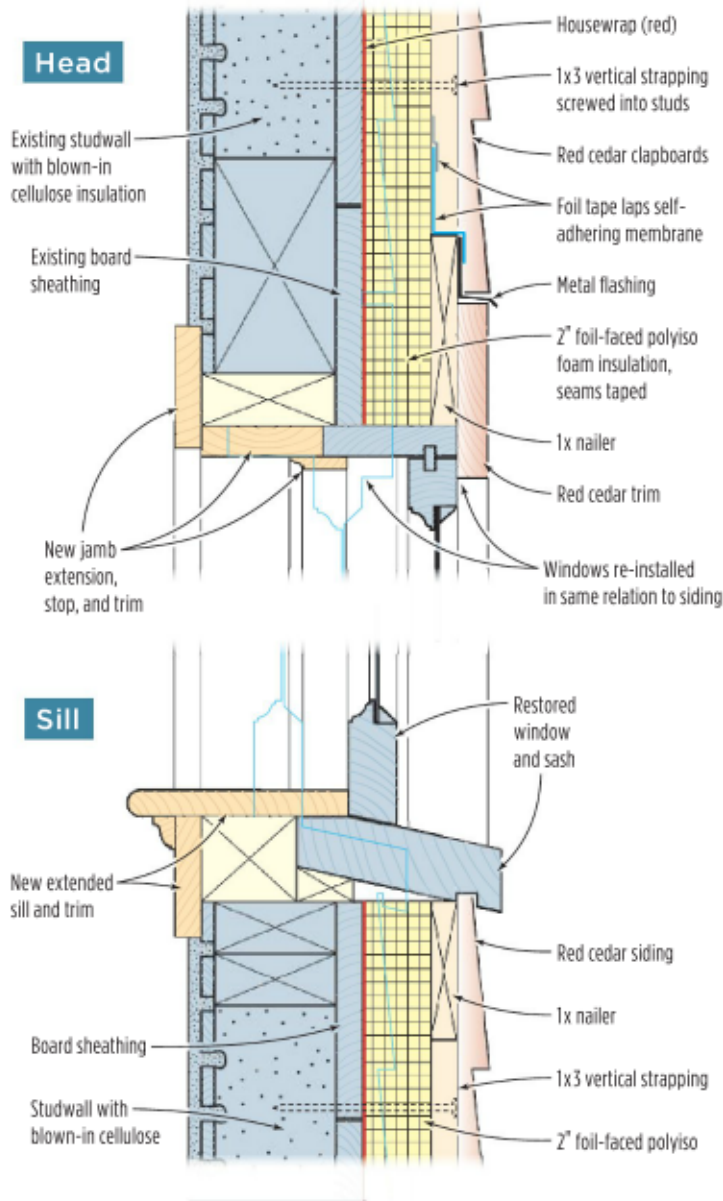
Window Installation Details

Reinstalling the windows. To match the original building façade, the restored windows were mounted flush with the furring strips. This required jamb extensions (top) and deeper sills (above) to accommodate the thicker wall.

One area where the commissions left no room for compromise was the windows. They insisted that we reuse every window deemed original. And they insisted that the windows be re-installed in the same relation to the siding as on the original building (see illustration, left). Therefore, all original windows were taken off site and painstakingly restored before being reinstalled. Non-original windows were replaced with new units that closely matched the originals. Though single-glazed, the restored windows were much more airtight than they had been previously, and interior storm panels improved their performance even more.

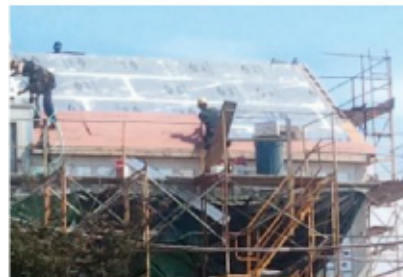
Figure 3. Plywood sheathing, screwed through the foam insulation on the roof and into the rafters, provided continuous nailing for the red cedar roof shingles. The seams were taped per the manufacturer's instructions, and a mesh drainage layer went between the sheathing and the shingles.

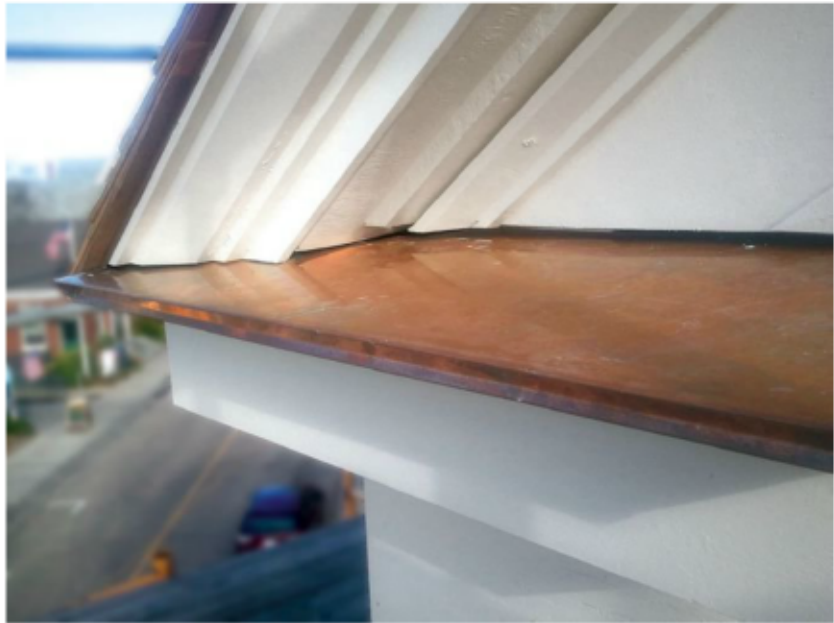
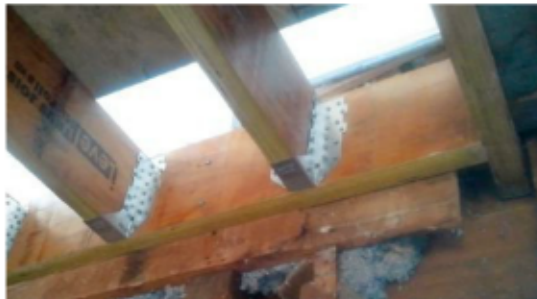
Figure 4. When the trim went back on the building, original detailing was followed as closely as possible based on archival photos and the trim that was removed (above). Metal connectors and beams were added where the old structure needed strengthening (left).

added about 5½ inches to the overall width and length of the building and 2½ inches to the height, changes that both commissions found acceptable as long as we faithfully reproduced the eaves, rake, and return details (Figure 4). The original trim on the building was cyprus, and we repaired and reused what was salvageable. We used red cedar for any replacement trim, a choice that was cost-effective and met the commissions' requirements. (Neither synthetic trim nor non-wood siding was an acceptable option.)
