Roughing Out Site Work Lessons learned taming a difficult site

BY ANDREW BORGESE

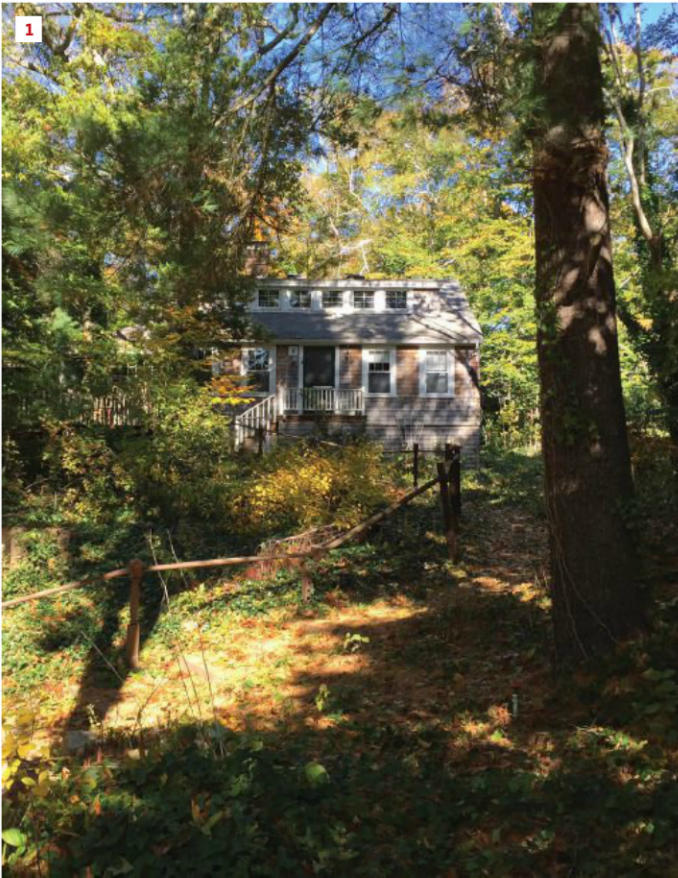
the scope of the work. On this Cape Cod project, the clients owned a small cottage that sat in the back of a narrow, overgrown lot (1). Built in the 1940s, the existing house was so far from being code compliant that demolishing it and salvaging materials from it was more financially feasible than trying to renovate it.

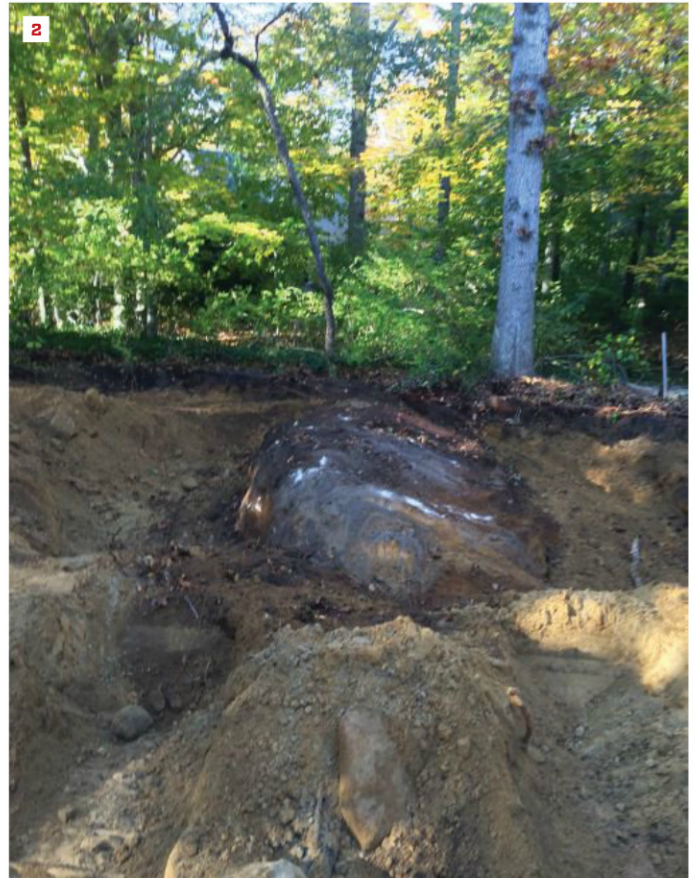
When I first visited the property, I noticed that the back corner of the house sat on what appeared to be a large boulder (2). But with no other such outcroppings visible as the site sloped downhill, I wasn't overly concerned and didn't feel that my observation justified spending thousands of additional dollars to do soil borings throughout the lot to investigate what obstructions, if any, might lie beneath the surface. My excavation contractor had done extensive digging in the nearby area and although he had encountered some poor soil and rocks, he wasn't too concerned either.

However, as a precaution, we decided early in the design phase to locate the new house closer to the road (and farther away from the visible outcropping of stone). We also designed the rear uphill portion of the house to sit over a crawlspace with a shallower foundation; a full foundation would have required a much deeper excavation in that area.

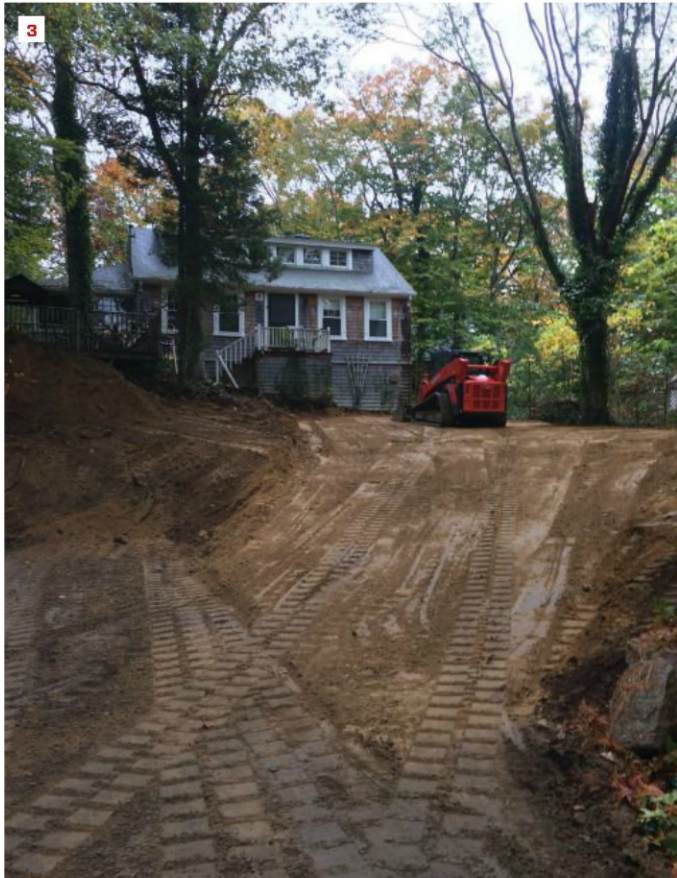
The rough site work began with clearing any trees and vegetation located within the footprint of the new structure and in the access path of construction vehicles (3). In this case, that meant getting the site ready for the equipment that would raze the house and remove the debris.

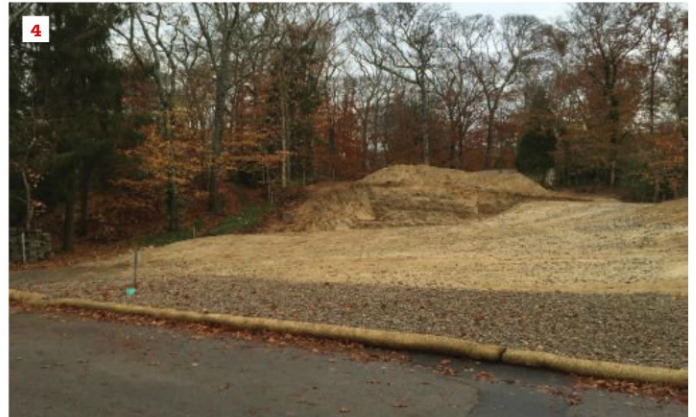
Mud mat. One of George's first tasks was scooping out a 12-foot-wide by 10-inch-deep area along the length of the property where it abutted the street (which was also the lowest elevation of our sloping lot). He filled the resulting wide, shallow trench with crushed stone to create a large "mud mat" to filter runoff from the site and to help remove dirt from the tires of construction vehicles.

Straw wattle. As an additional measure, we placed a straw wattle along the edge of the crushed-stone mat, parallel with the roadway. This wattle is a biodegradable woven tube filled with absorbent fiber designed to collect any silt or debris that might get past the mat,

and requires no special removal after it begins to break down from wheel traffic. The combination of mud mat and straw wattle was incredibly effective in keeping the roadway clean despite several days of heavy downpours during the excavation (4).

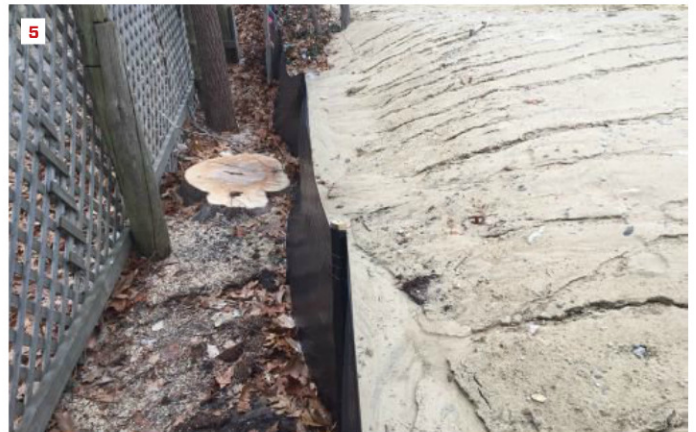
Silt fence. To keep mud and debris from washing off the site onto neighboring properties on both sides, we installed a silt fence made from a plastic fabric that holds back soil while allowing water to pass through. We buried the bottom 6 inches of the fence in the ground, and it, too, was quite effective in keeping the excavated soil contained on site (5).

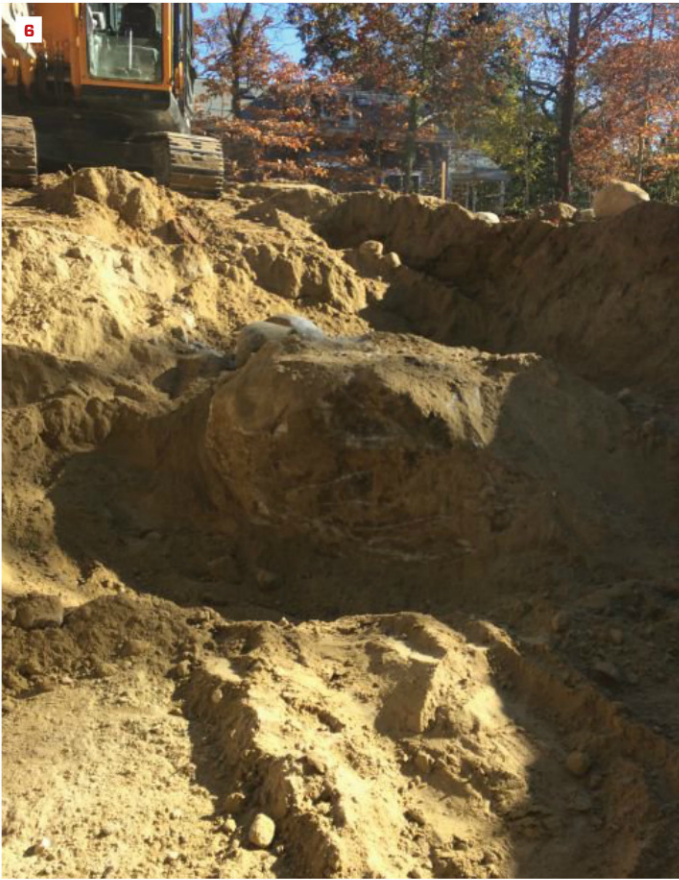
Rock bottom. After removing 967 yards of clay and silt (George kept close tabs), we thought that we had exhausted our bad luck and had hit rock bottom. That is, until we actually hit rock. About 18 inches above our designed slab elevation for the crawlspace area, we hit glacial till. George found a "rock" that kept getting bigger as he tried to dig under and around it (6). It was not to be moved.

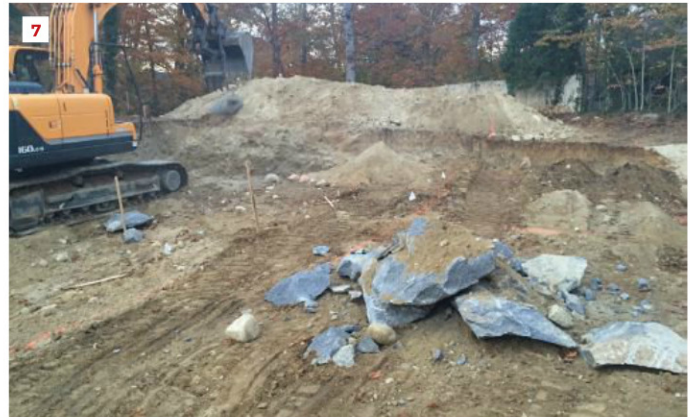
The densely developed neighborhood where this property was located was definitely not a "blast-friendly" zone, so breaking up the rock with explosives was not an option. Breaking it up with a pneumatic impact drill was also ruled out as being too noisy. Instead, George chipped away at the stone protrusion by repeatedly dropping a one-ton steel-alloy weight (appropriately nicknamed "the head-

ache ball") from the bucket of his excavator (7). Eventually he broke the rock down to the desired elevation for the slab.

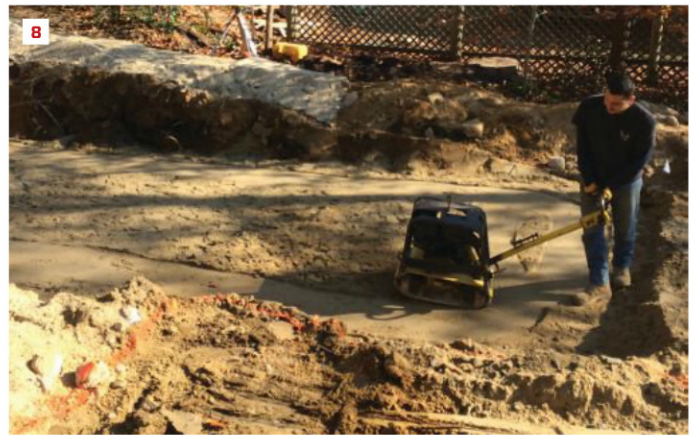
Driveway base. Part of the excavation process was preparing the driveway area for the heavy construction vehicles, including the concrete pump truck, that would need to drive up the hill. A good driveway that would provide access to the main floor of the house was also a crucial part of the plan. George excavated the poor soils from the driveway area and brought in clean, structural fill that he installed in 6-inch lifts, compacting each layer before placing the next one (8).

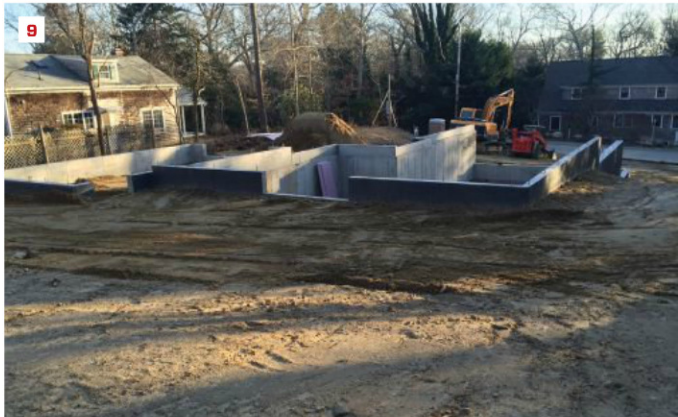
The footings and foundation for the house and garage went in smoothly. To put the main floor of the house at an accessible level, the foundation contractors formed a shelf in the upper part of the walls. It would support an I-joint floor that would be at the same

level as the grade at the driveway and garage floor. On two sides of the house, the foundation walls extend almost two feet above the shelf to allow the grade next to the foundation to be higher than the floor and then slope away from the house properly (9).

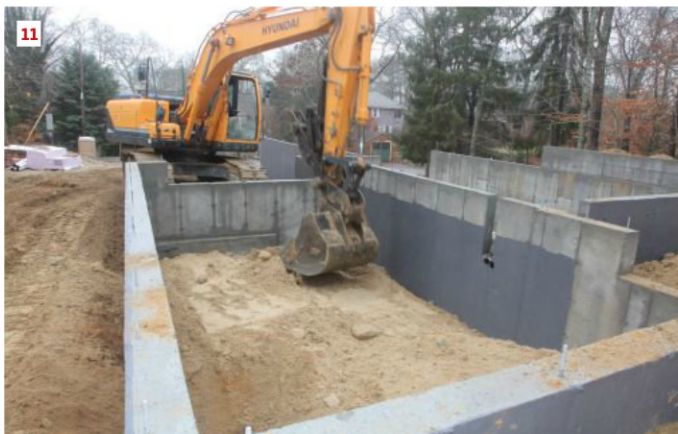
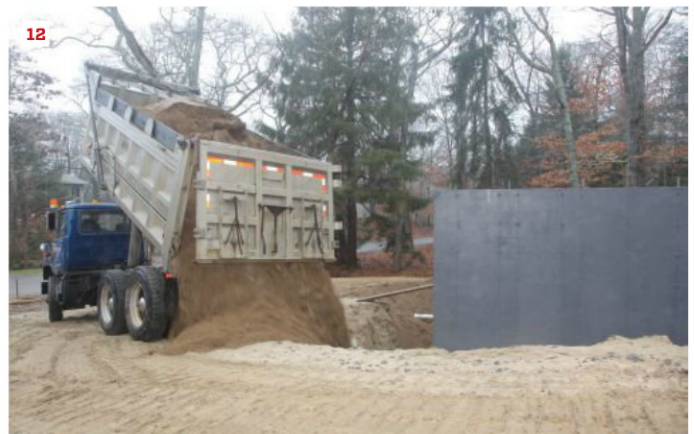
Backfill. Now it was up to the excavator to backfill the foundation and finish the rough grade for the driveway to bring it all together. Using the bucket on his excavator, as well as his skid steer, George backfilled around the foundation at the back and sides of the house with excavated material that had been piled behind the house (10). He also used the bucket to fill the foundation of the garage with clean material, which he compacted using the bucket and a hand-operated compactor (11). To make up for the materials that had been hauled off site, George brought in 400 yards of screened and structural fill material to finish backfilling the sides of the foundation and to fill the rest of the garage foundation as a base for the slab (12).

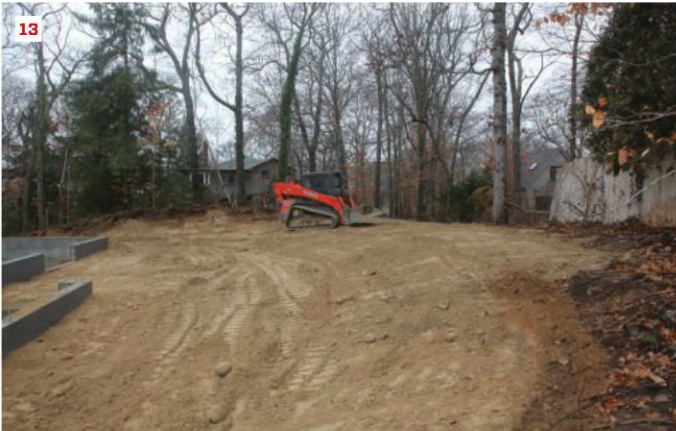
the only area that would work was behind the house. But the topography there continued to slope uphill, so our original design called for cutting into the grade and containing the patio area with 3-foot-high retaining walls. After backfilling the foundation, George began roughing out the ground behind the house. Sculpting and smoothing the grade with the blade of his skid-steer machine, he was able to carve out the area needed for the patio and then gently slope the grade up to meet the natural topography, eliminating the need for thousands of dollars worth of retaining walls (13). Those savings at least put a dent in the unforeseen excavation expenses.

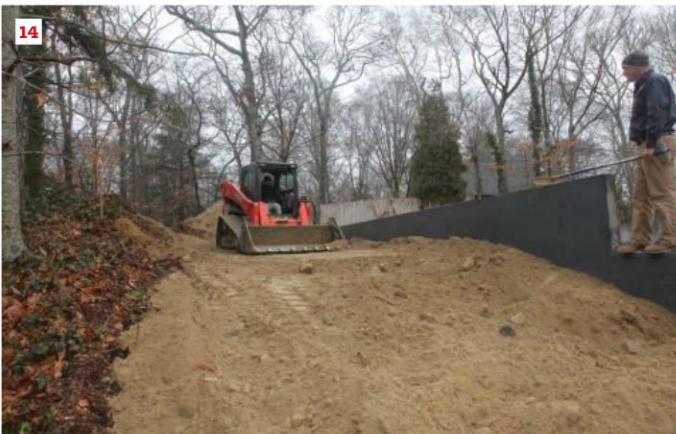
One of the last steps in the rough grading was making the site safe and ready for the framers. This involved smoothing the ground with the skid steer after the backfill was placed (14), and hand-grading the area immediately beside the foundation to get rid of what George called “ankle breakers”—chunky soil that when frozen can be dangerous underfoot (15). Ideally, this last step would have been completed after the septic system (located

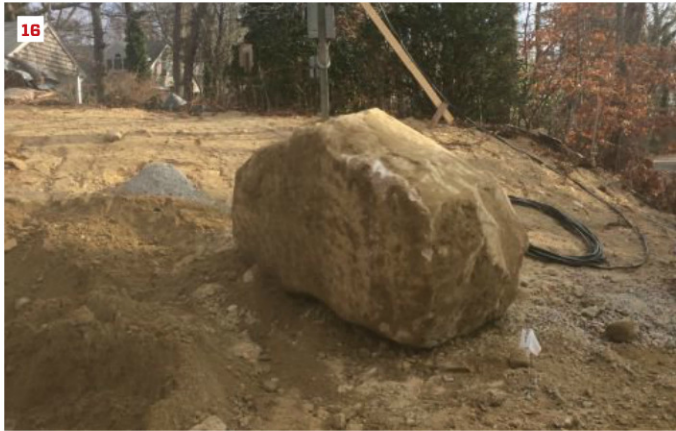
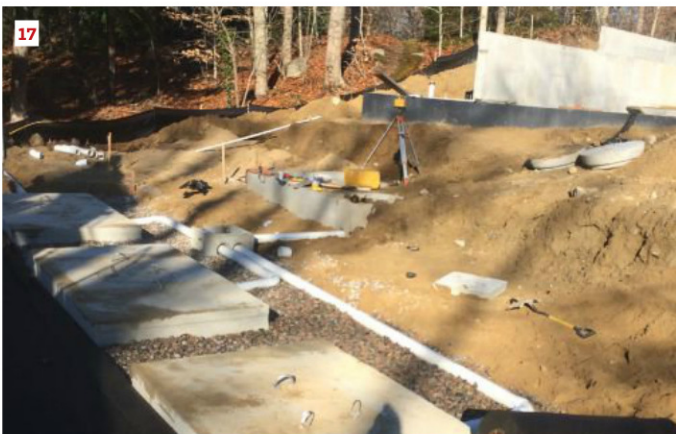
Unfortunately perc tests don't reflect all of the conditions below grade, and excavation for the septic system uncovered the same clay and silt mixture that we'd found earlier. It wasn't until we reached a depth of 25 feet below grade that we discovered suitable sandy material. To excavate for the septic system, George dug out some huge boulders (16) and ended up removing 1,121 yards of material, more than twice what we'd estimated based on the perc test. Within a few days, George was able to complete the septic system (17).

The initial perc test done a few months earlier had shown a 4-foot-deep layer of medium sand that started 10 feet below natural grade, so we budgeted for a 12-foot-deep by 48-foot-long by 20-foot-wide strip out for the new four-bedroom septic system. This would have equated to approximately 430 yards of soil being removed.

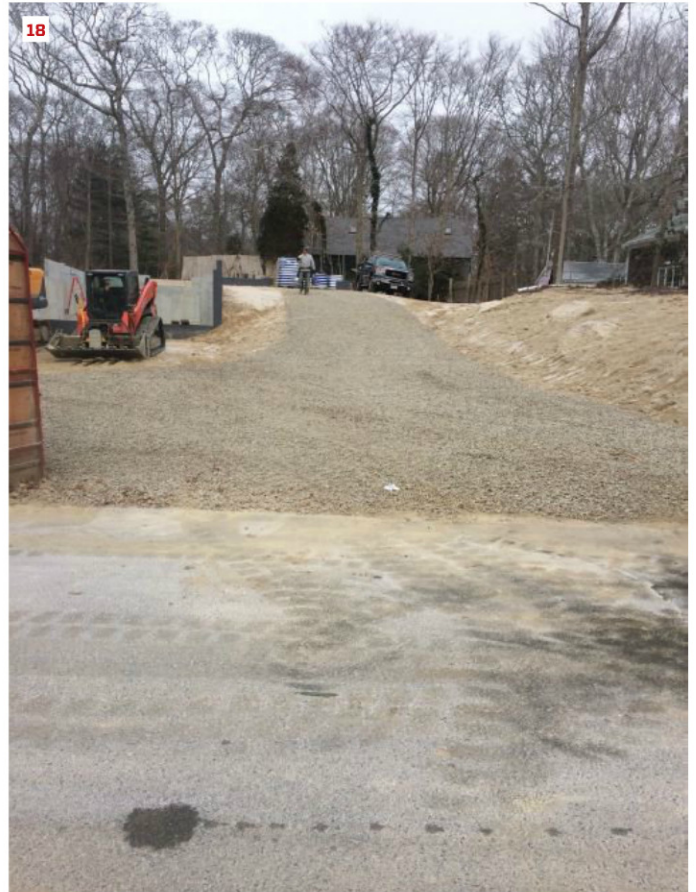
Before packing up his equipment and leaving, George put down a layer of crushed stone on the driveway (18). The stone will help keep the ground from turning into a soupy mess during freeze/thaw cycles as work progresses into the spring. The stone also created a clean, even surface for staging materials throughout all phases of construction that followed.
